**1. Headworks leaking wall Picture #1, with electrical panels. –**

2. Headworks leaking wall Picture #2 with Insulated Hot Water Pipe. –

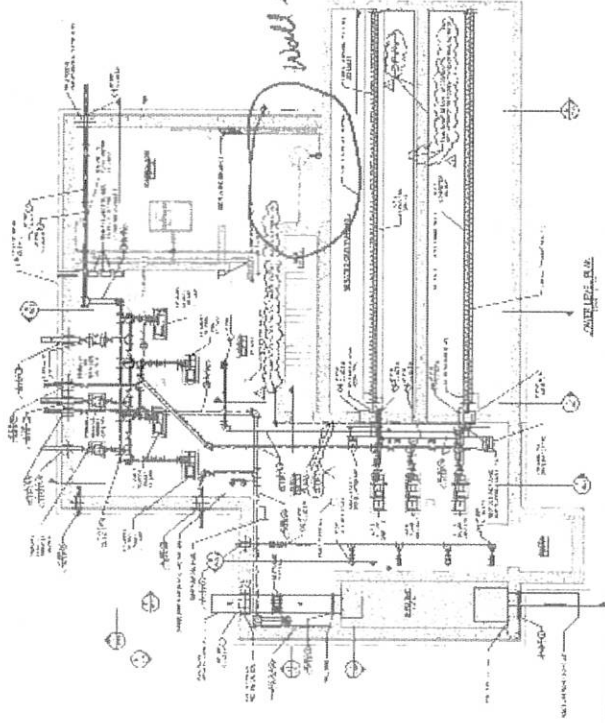
*well in question*

**Alleged Condition** – STP Staff alleges that the wall is leaking and is shoddy construction.

**Actual Condition** – This photo appears to be several weeks old. The headworks was put into service June 26 It does not show the completed work, and does not show that the leak has been addressed. The wall that the panels are located on backs up to the north grit channel. See attached drawing. The leak test on the channel was passed in January, 2019. All visible leaks were sealed at that time. At the time of the photograph, there are no visible leaks, just past leaks that were appropriately sealed during construction.

**Alleged Condition** – STP Staff also suggest that the control panels are covered in residue, and implying that they could be damaged.

**Actual Condition** – The issue is cosmetic, and it was addressed on the day that the picture was provided. These panels are not damaged. The streaky appearance is from water from the core drill process above the panels which ran down the wall. These panels have already been cleaned

up, and were not damaged in any way. The panels were inspected after the drilling process, and it was confirmed that the panels did not have any intrusion of water into the panels. Furthermore, the manufacturer certified the installation of the panels prior to putting the Headworks on line on June 26, 2019, and they confirmed that there were no warranty concerns.
